INDOOR AIR QUALITY EVALUATION REPORT

Annual Assessment

Jefferson Elementary School
518 Ridgewood Road,
Maplewood, NJ 07040

South Orange/Maplewood School District
525 Academy Street
Maplewood, NJ 07040
Attn: Mr. Thomas Giglio

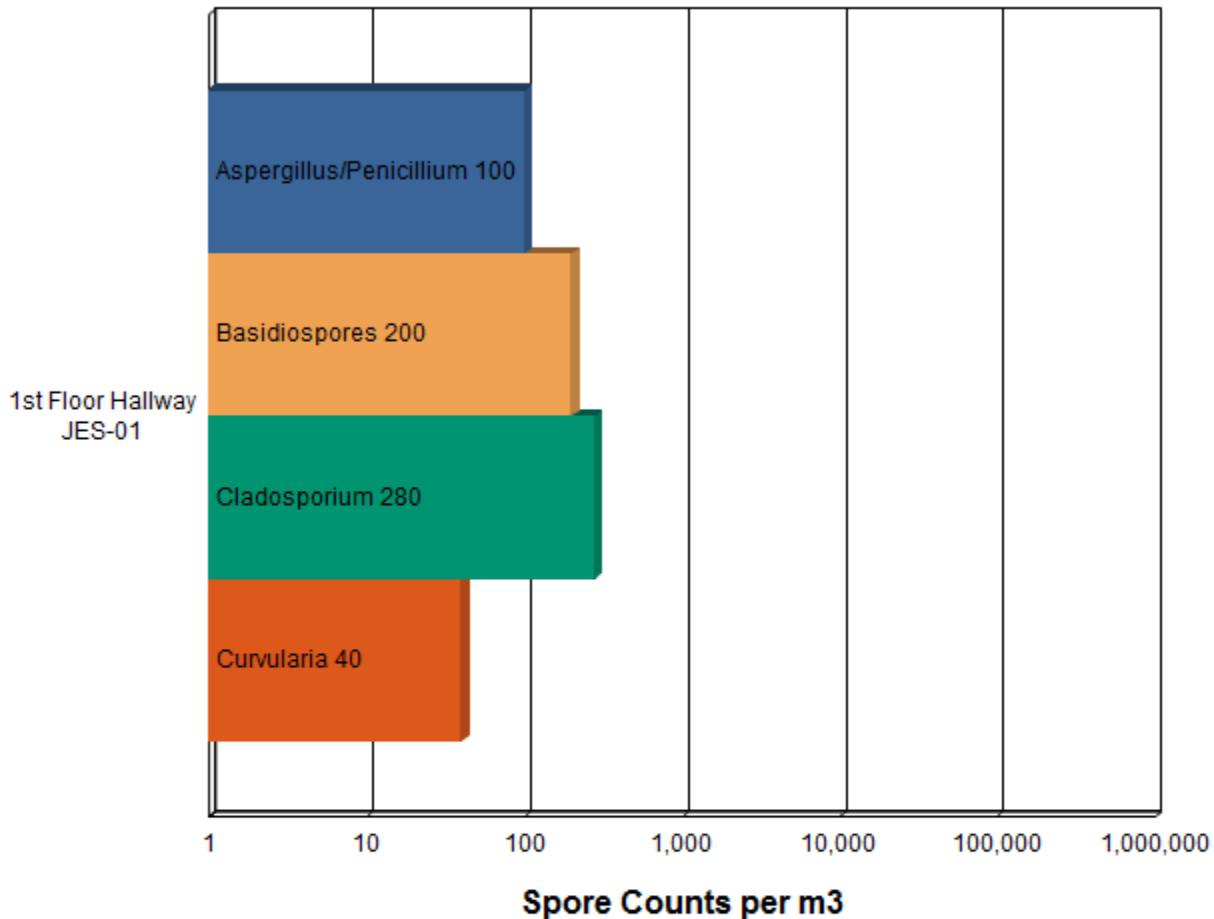
Spore Trap Report: Total Counts

* The chart is displayed using a logarithmic scale. Bar size is not directly proportional to the number of spores.

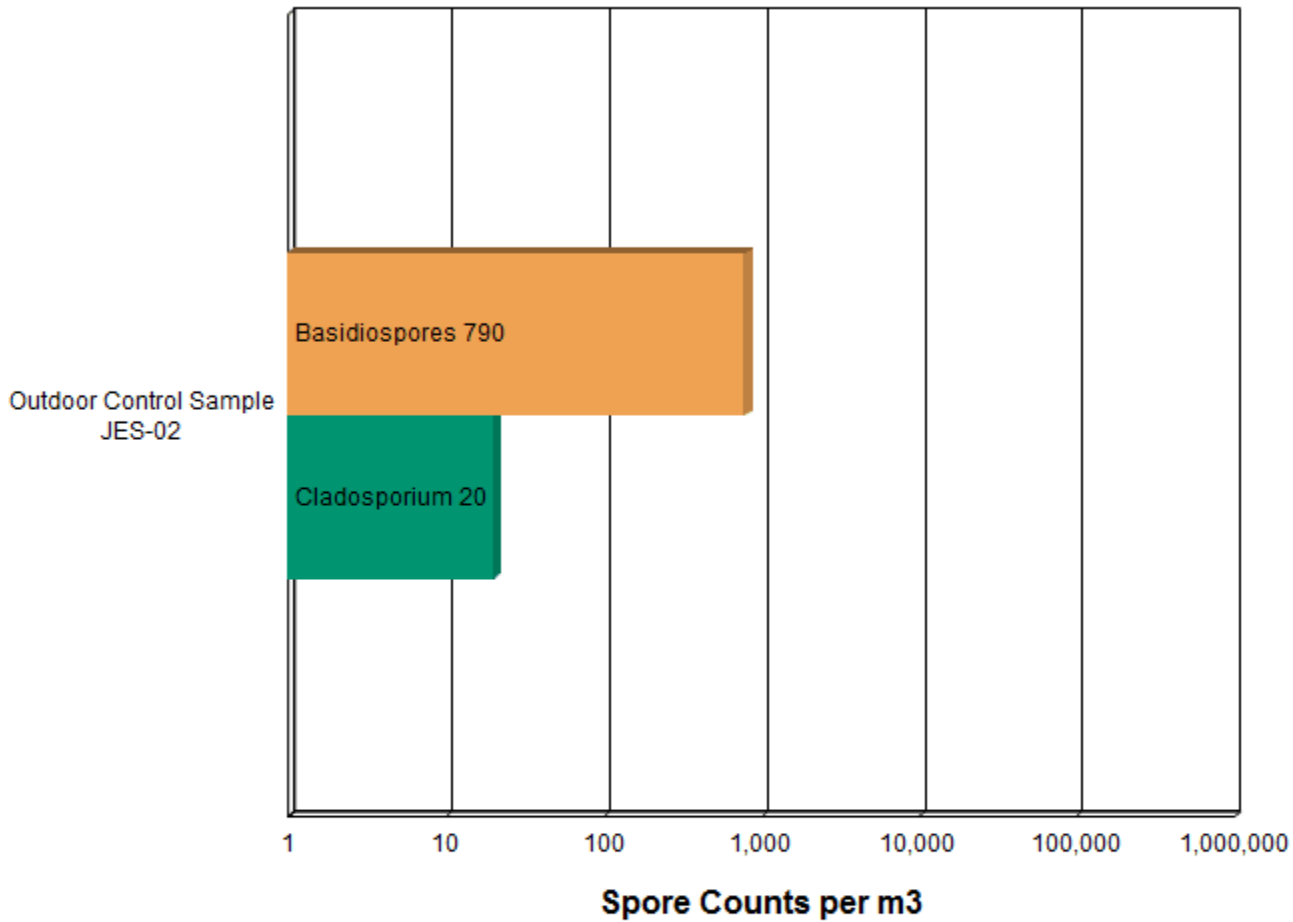
Spore Trap Report: Total Counts

* The chart is displayed using a logarithmic scale. Bar size is not directly proportional to the number of spores.

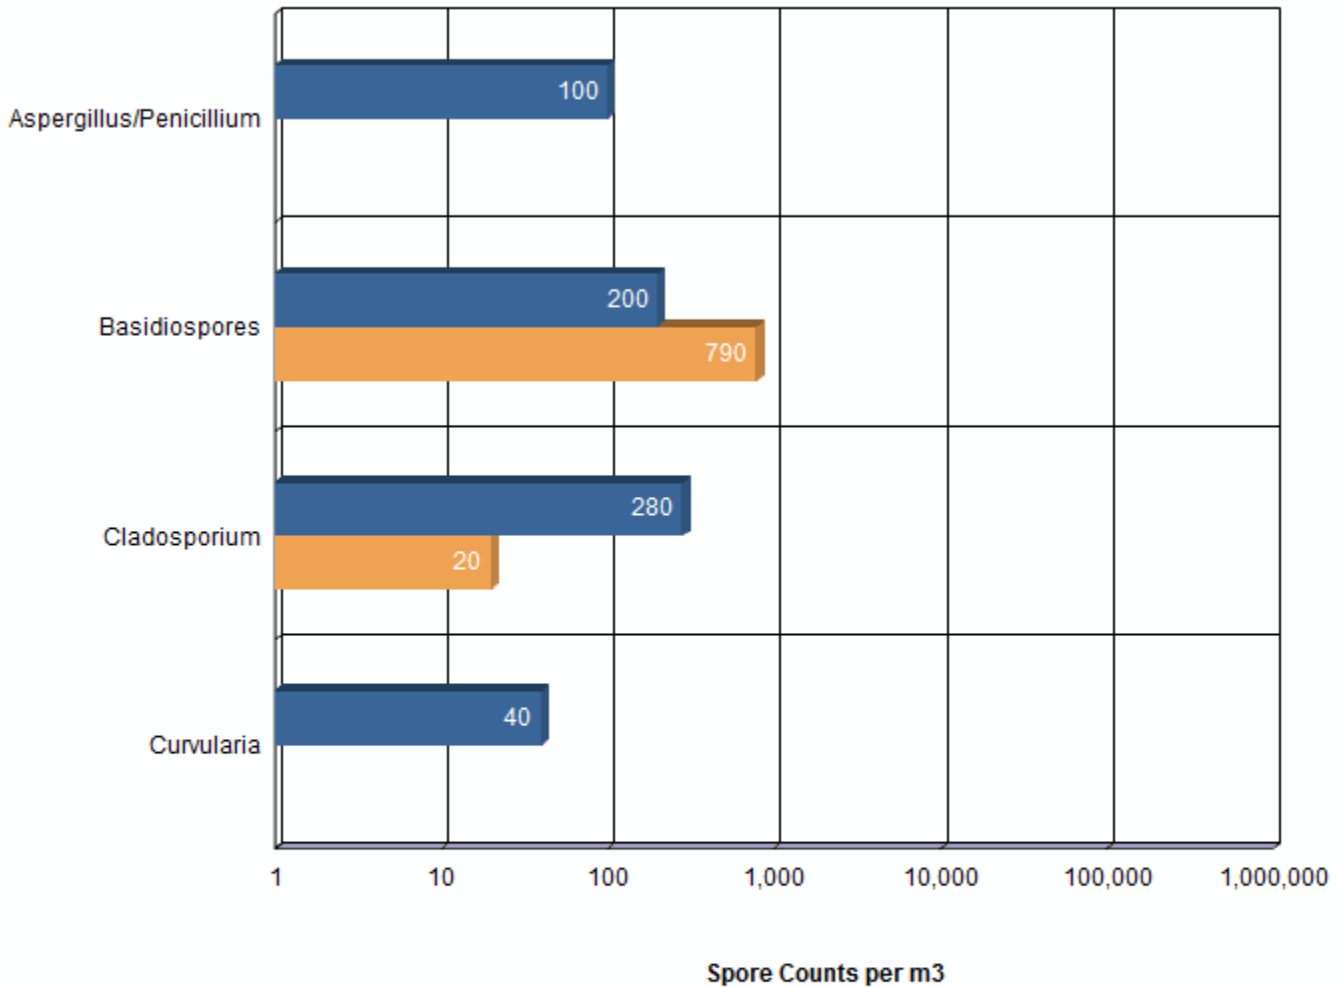
Background Comparison Chart

* The chart is displayed using a logarithmic scale. The bar size is not directly proportional to the number of spores.

Results: Concentrations of indoor fungal spores were comparable to and less than the outdoor control sample with respect to the total counts of fungal structures per cubic meter of air (FS/m³). No visible active mold growth was observed at the time of this assessment.
